Annual Report 2022

Message from the Administrator

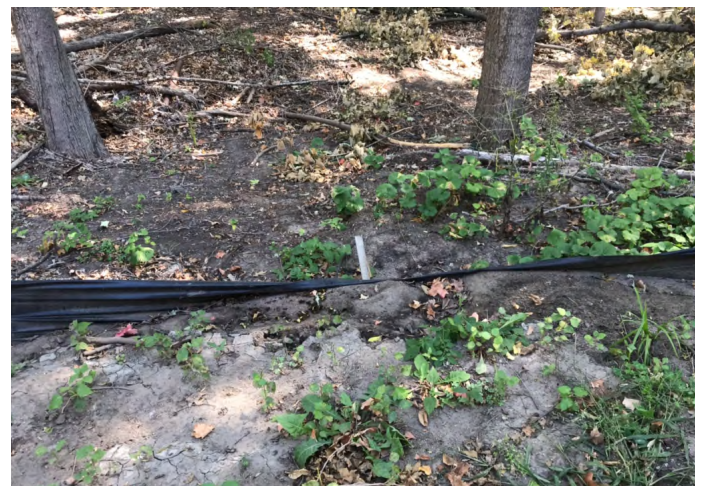
District staff inspect project sites and direct permit holders to take corrective actions as needed to protect water quality. The image above shows a silt fence violation (failure) at a site in 2022.

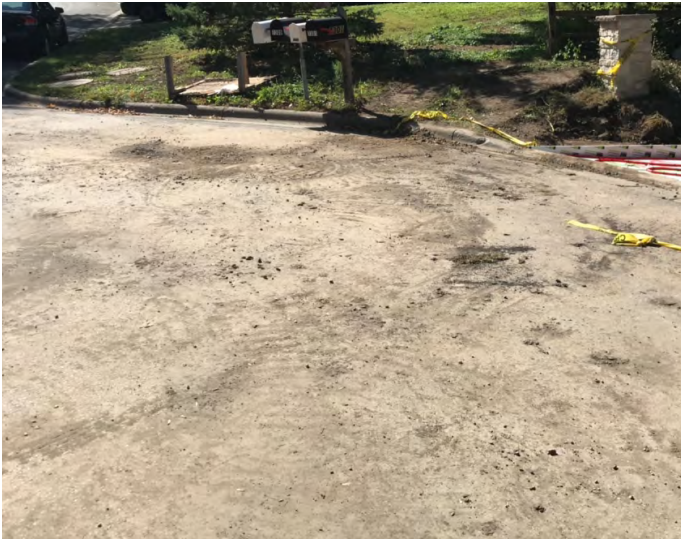
The image above shows tracking of sediment onto a street from a 2022 construction site, which violates District permit rules.

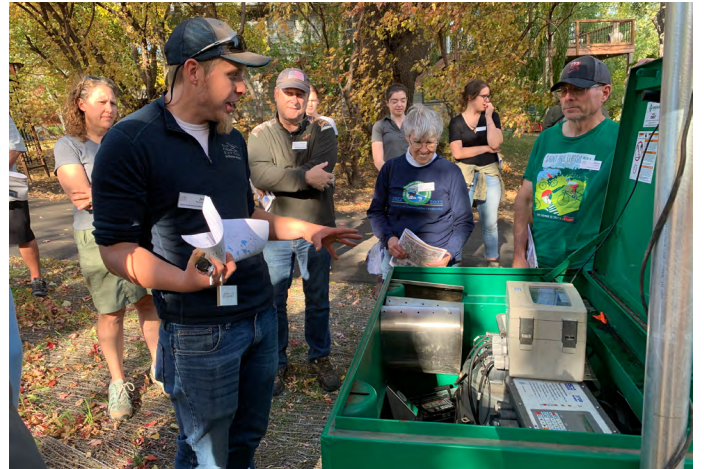
Josh Maxwell, Water Resources Coordinator, explains operation of the automated sampling unit for the Kraken filtration units for the Rice Marsh Lake Stormwater Management Project (Stop 3).

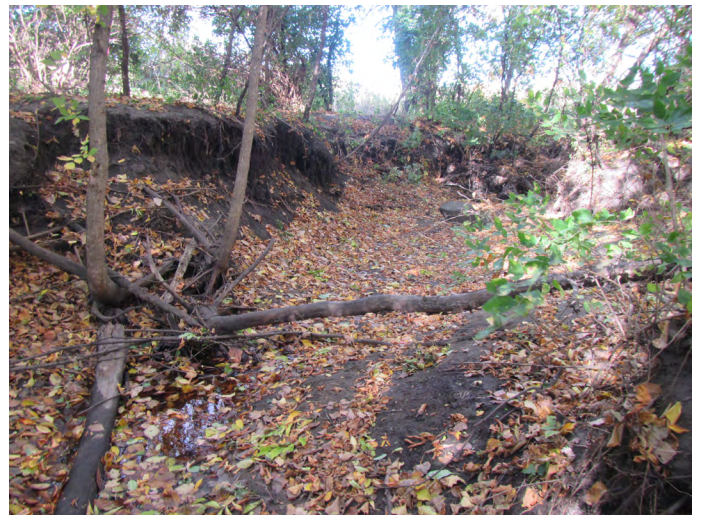
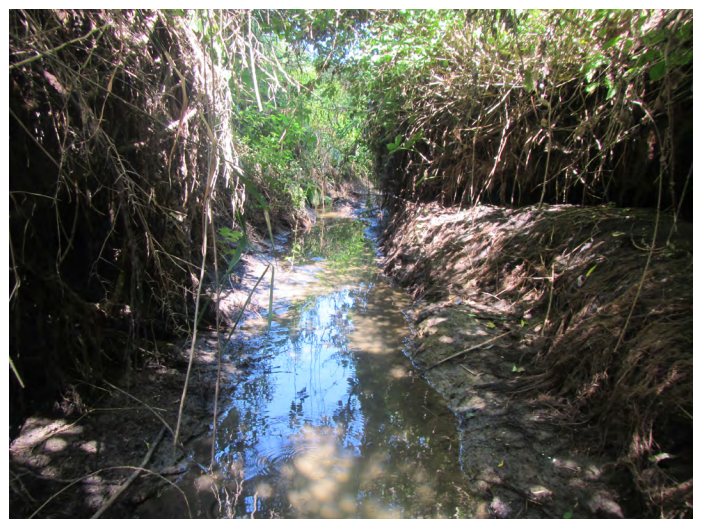
Images of eroding banks and incised channel of Riley Creek - Reach 4 (R4) from 2022.

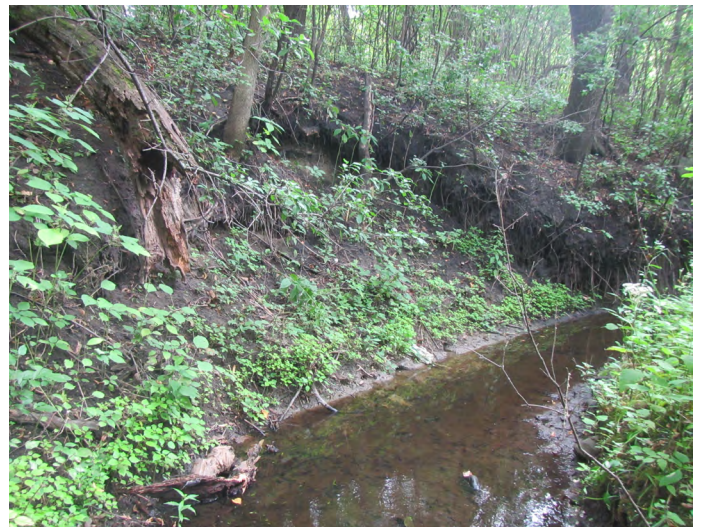
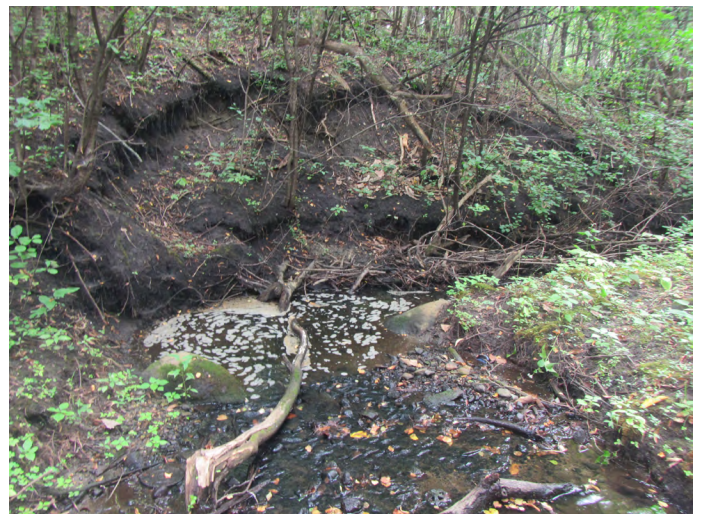
Images of eroding banks and incised channel of Bluff Creek - Reach 5 (B5) from 2022.

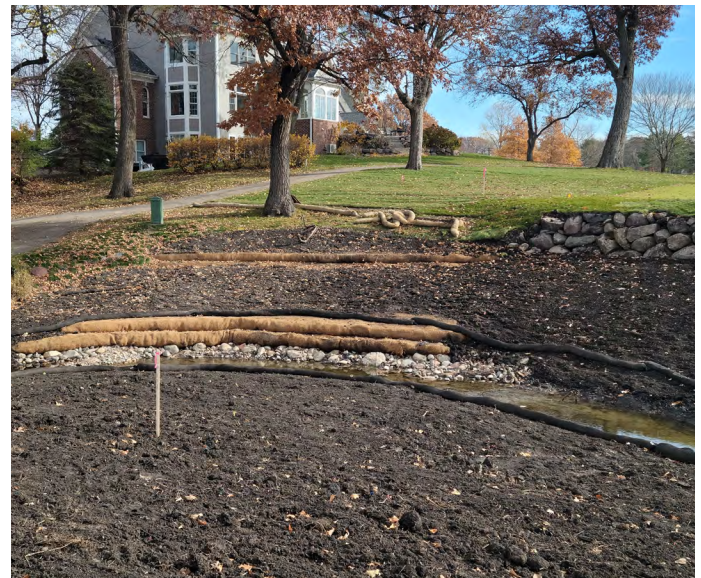
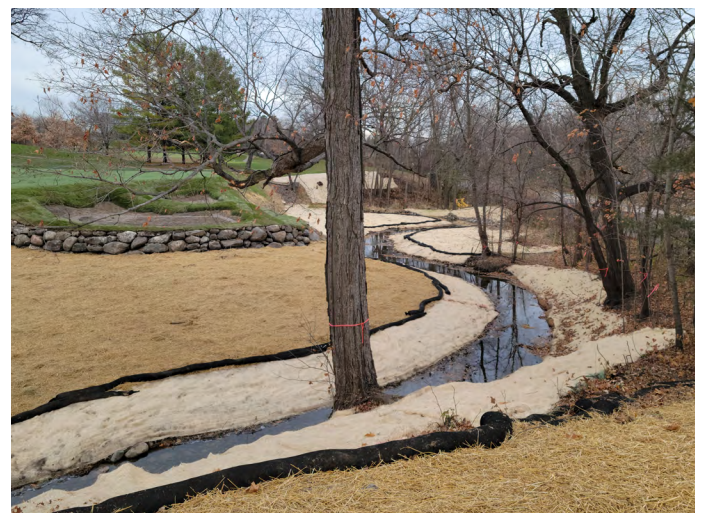
Re-meandering and bank stabilization of Riley Creek within Bearpath Golf and Country Club in November 2021.

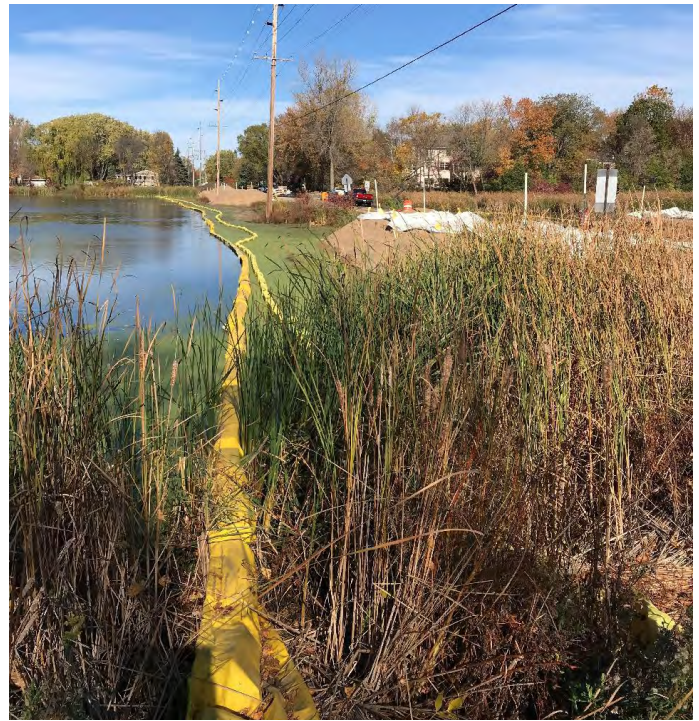
A double row of yellow silt curtains in the water protect the lake from the Duck Lake Road construction zone (fall 2021).

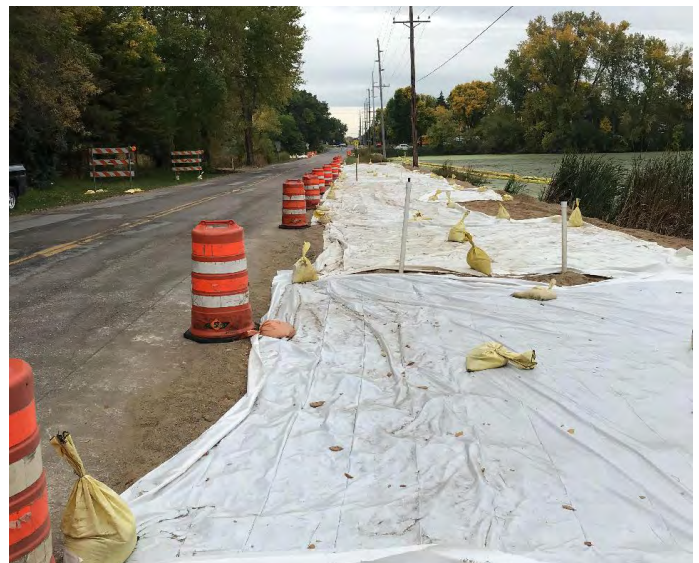
Covering exposed soils during road work reduces the risk of erosion into Duck Lake (fall 2021).

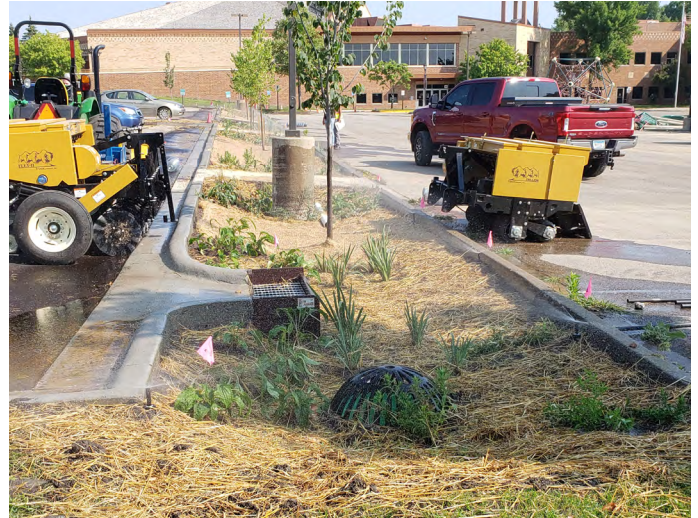
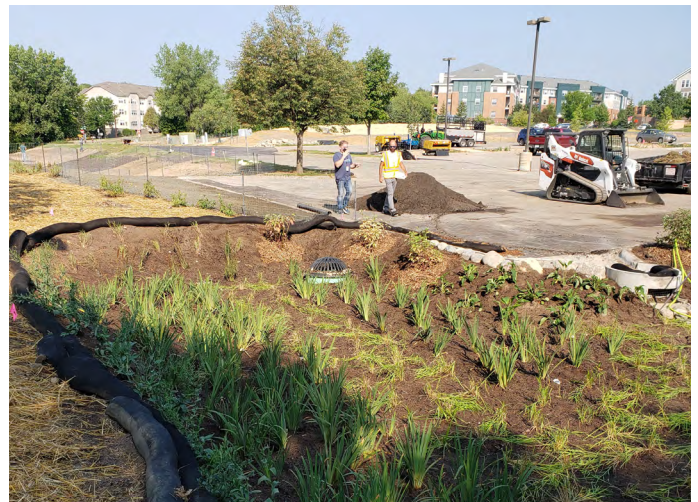
Photos taken during the installation of the St. Hubert Opportunity Project.
